For: Bellmount Development Ltd.

Proposed Residential Development

Road Safety Audit Stage 1 / 2

July 2022

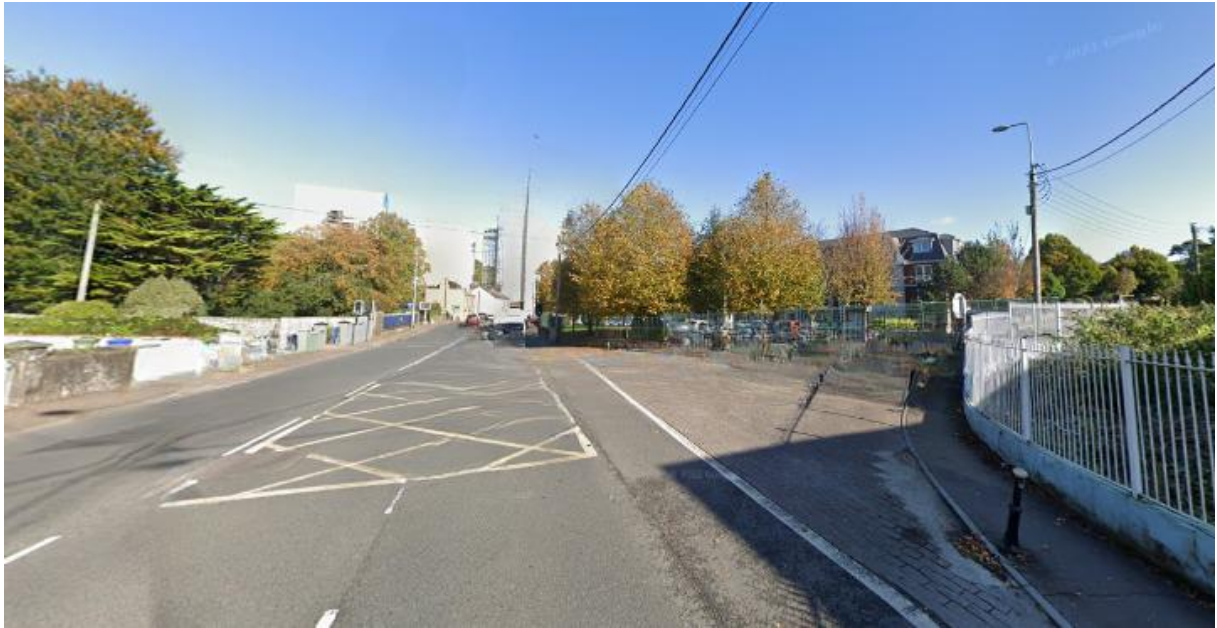
Figure 5.5 Existing junction with Wilton Road/ Orchard Road

No junction sightline layouts for the change in nearby junction, with reference to proposed streetscape planting provided to the audit team. Failure to provide adequate sightlines could result in collisions between vehicles, or vehicles and pedestrians, due to poor forward visibility. See Appendix A.

It is proposed to realign the existing pedestrian crossing on Orchard Road, parallel to Wilton Road, as part of the junction realignment works. Failure to provide adequate intervisibility for and to pedestrians at the crossing could result in collisions between vehicles and pedestrians, due to poor visibility. See Appendix A.

Ensure appropriate sightlines for the design speed of the Wilton Road are provided.

Ensure appropriate intervisibility is provided to and from the pedestrian crossing, appropriate to the road design speed.
